"OVIDIUS" UNIVERSITY FROM CONSTANȚA
DOCTORAL SCHOOL OF APPLIED SCIENCES
DOCTORAL DOMAIN: CIVIL ENGINEERING

*Theoretical and experimental study on the behavior of
typical floors of heritage buildings.
Restoration solutions*

- PhD thesis summary -

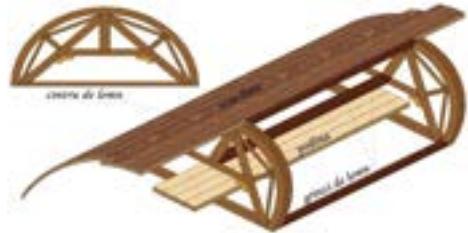
Fig. 2.54 - Vaults with wooden shuttering centerings - (author drawing)

To strengthen and restore vaulted floors first must be made a structural support system to structural and nonstructural elements to avoid potential crashes. Along with the support system the working platform is built at the floor intrados and also the scaffolding [33].

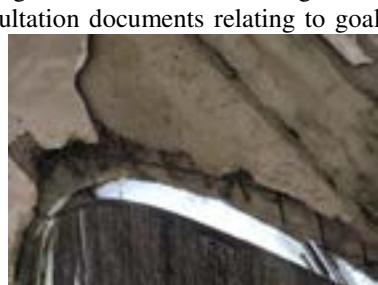
Fig. 3.72 – Investigation of cupola floor – (photo autor)

This case study is based on analyzes and investigations carried out on the ground, and studies conducted in the State Archives, consultation documents relating to goal planning consulting projects, monographs and other publications with reference to objective study. The construction of the water tower is a historical monument of importance class B, appearing in the list of historical monuments code BR-II-mB-02104.

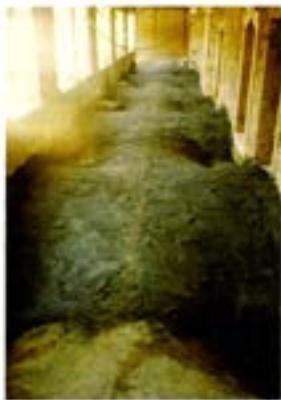
Fig. 4.5 - Jacketing of masonry vaults polymer mesh - (photo João Appleton)

Fig. 4.6 – Layout staples - (photo Grămescu Ana Maria)

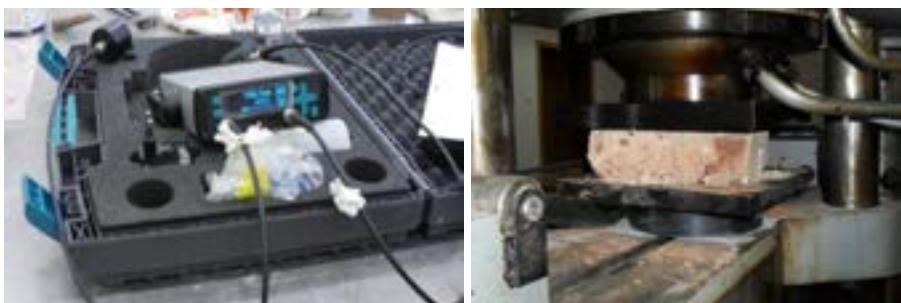
The samples used in the tests were taken from the superstructure of building declared a historic monument in Romania. The processing of the samples consisted of surface treatments to be as straight as removal of dust particles, measuring and weighing them. The site chosen for sampling had to meet several requirements: be easy to work in the space and there is severe damage to the area because the evidence is not already cracked.

Fig. 4.29 - Trying destructive compression - (photo author)

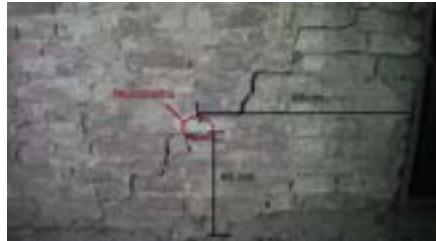
Fig. 5.38 - Details on emplacement

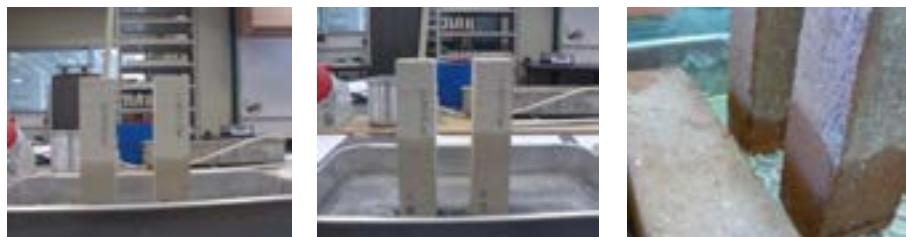
The four side faces of the specimens were waterproof, in order to avoid water evaporation during the test (by applying a resin on the four lateral sides) or it can work without waterproof four sides. The aim is to raise the height of the water on the lateral sides. The test was carried out in an atmosphere saturated achieved by using a cover covering the tray in which the test pieces [283] to prevent evaporation of water from the sides.

Fig. 5.43 – Water absorption by capillarity test on mortars and bricks – (photo author)

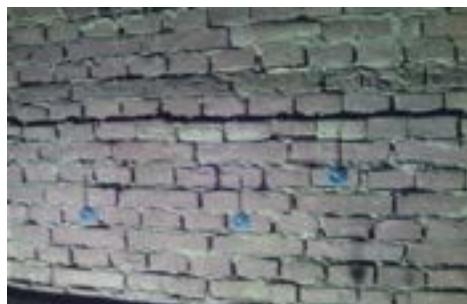
This test is used to measure the amount of water absorbed (low pressure) surface of a porous material, after a certain period of time [205].

Fig. 5.48 - Determination of water absorption of low pressure in situ - (photo author) – left image
