## THESES OVERVIEW

# CONTRIBUTIONS ON REDUCING RISK FACTORS FACED BY HISTORICAL MONUMENTS BUILDINGS LOCATED WITHIN THE ACTIVE OF THE BLACK SEA CLIFF. SOLUTIONS FOR USING THE LIMITED SAFETY

Doctoral student:  
**Engineer Simion (Gemănaru) Ancuța**

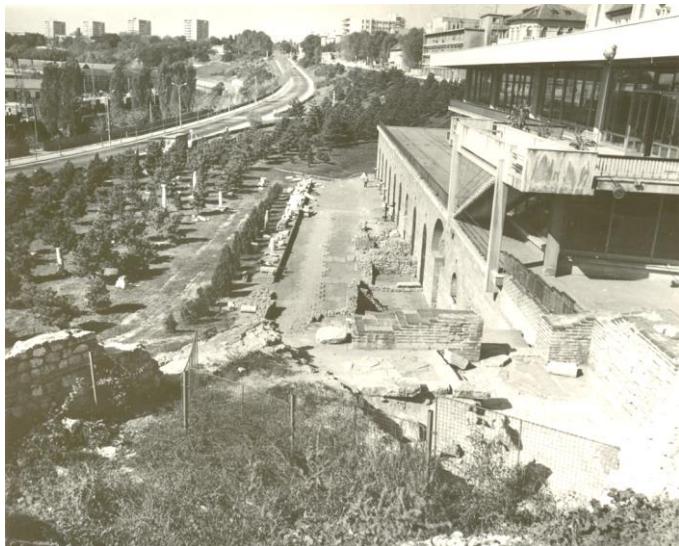
General view of the cliff area, from the South side of Ovid Street

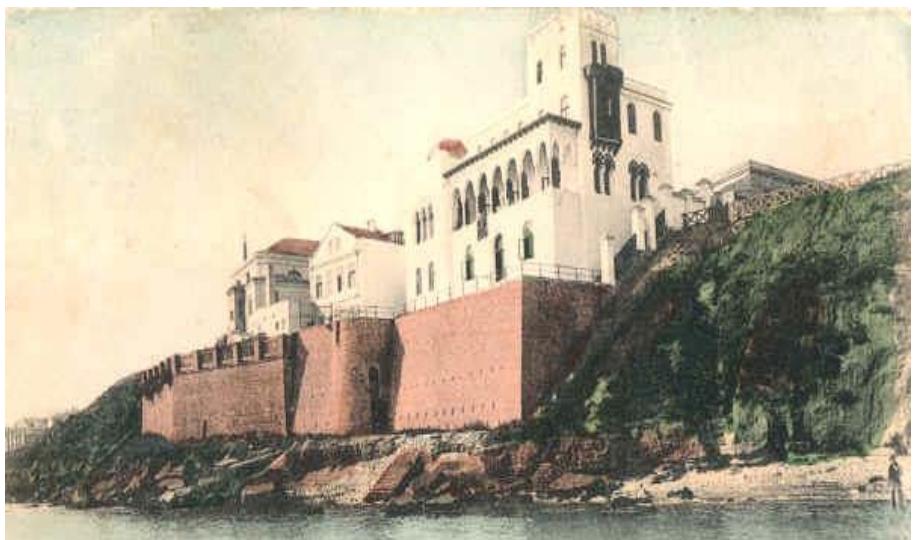
*Figure 3.5 – photo taken in 1902 – 1903*

In the foreground we can see the rock on which the supporting wall was built with its drainage system for capturing the water at the loess basis

The building is located in the eastern part of the peninsula (*Figure 3.5*), on Tomis harbor cliff, inside the urban space representing the historic centre of Constanța City.

Behind the wall a filled platform was built all along the building front side. The foundation of the villa was made of stone of various sizes and depths. The founding land is made up of macroporous loess sensible to humidity belonging to «A» sensibility category. (*Figure 3.5*)

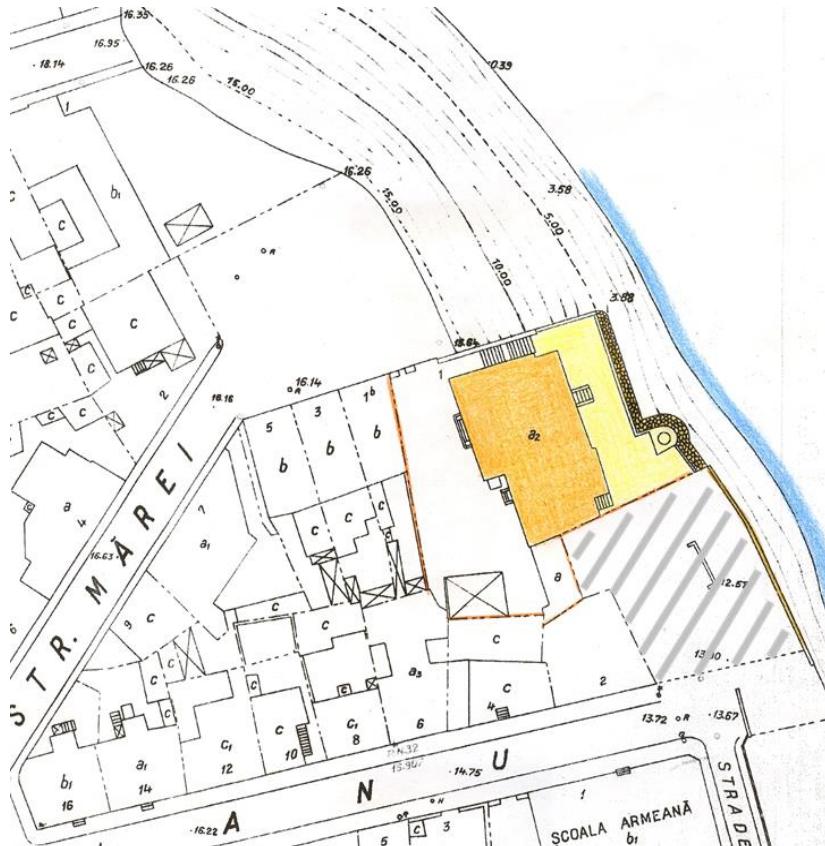
- cladirea vilei (subsol, parter, etaj)
- zid pentru stabilizarea falezei, modificat fata de proiectul initial, pentru racordarea la zidul existent in partea de sud
- platforma de umplutura pavata
- zone construite in anii 1880 – 1890, afectate direct de instabilitatea falezei

The wall was made of semi polished stone glued with cement mortar, having a 1 m width, placed directly on the Sarmat calcareous rock after the deteriorated layer was removed from its surface (superior quota of the calcareous layer is at about 2,5 – 3,0 m from the sea level).

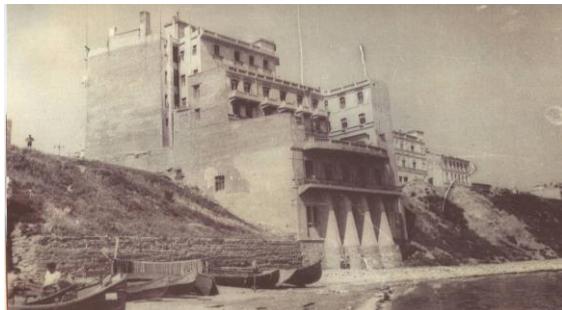
Figure 3.14 – National Bank - front side East- 1960 photo before the beginning of the organizing works for Tomis touristis marina (Archives of Constanța City Hall)

It was built the South Eastern part of Ovid Place (*Figure 313*). The building covers the margins of the high cliff: from 17,50 m front side and the side part up to about 1,20 m to the current platforme of Tomis touristic marina. (*Figure 3.14*).

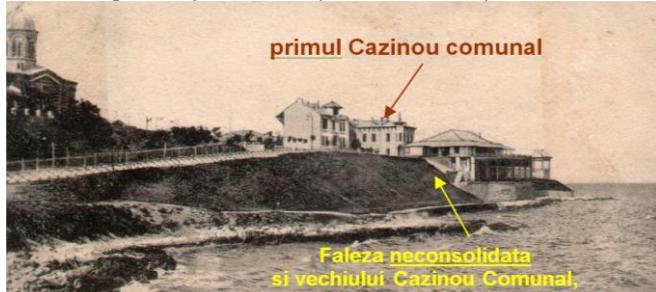
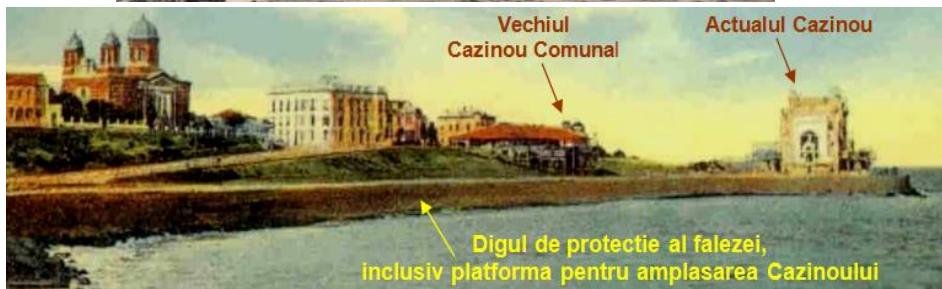
*Figura 3.18 – Arranged cliff with dam and the new Casino  
(photo of Archives of Constanta City Hall)*

The partnership between the City Hall and the engineer Anghel Saligny between 1903-1904 led to the building of the cliff protection, including the platform for the placing the current Cazino, allowing the final and safe organization promenade area. (Figure 3.18)

Between 1904-1905 begins the design for the current **Cazino, in perfectly safe conditions.** (Figure 3.18)

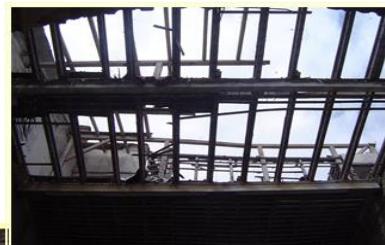
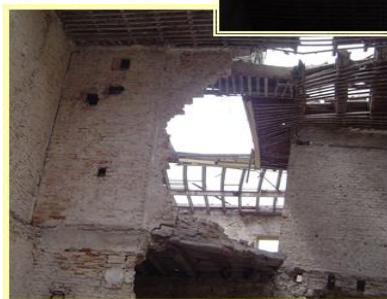
Str. Ovidiu  
- constructie in stare de  
precolaps -

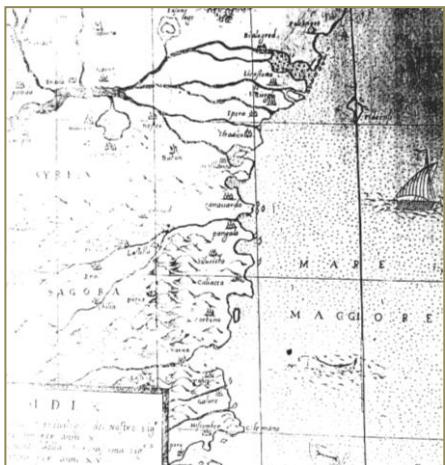
*Figure 4.2 (Archives of Constanta City Hall)  
Drawing made in 1854 by MD Quesnoy showing the North part of the peninsula very different from the current one, with the rapid cliff collapsing episodes*

A drawing made by Dr Quesnoy in 1854 shows the form of the northern part of coast in the peninsula. The only element for comparison with the current state is the minaret of the Turkish Church built in 1828, marking the southern end of Ovid Place of these days. *Figure 4.2* shows three promontories with a much more advanced position towards north.

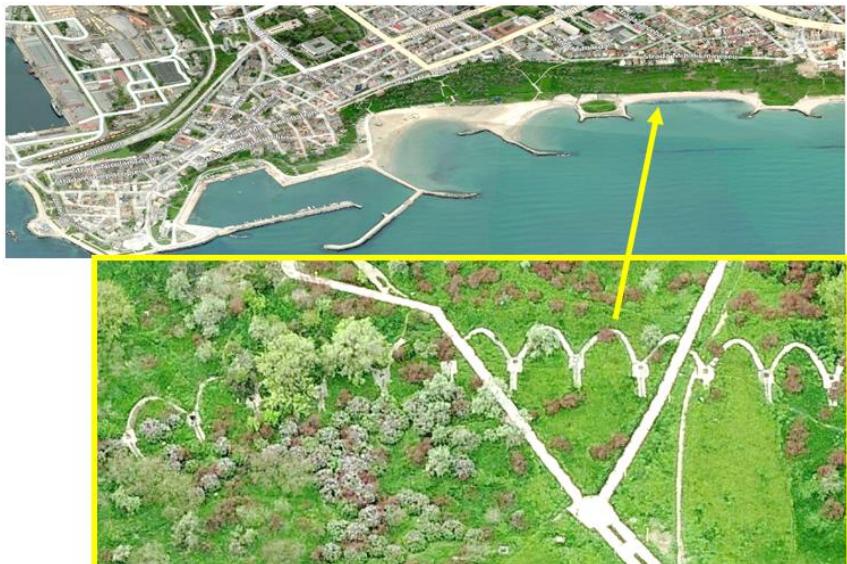
Figure 4.6 – Coast stabilization, East Cliff, carried out by IPTANA Bucharest between 1956-1957 – google maps – satelite

Some places were planted and reinforced with supporting arch walls in order to stop the land sliding.

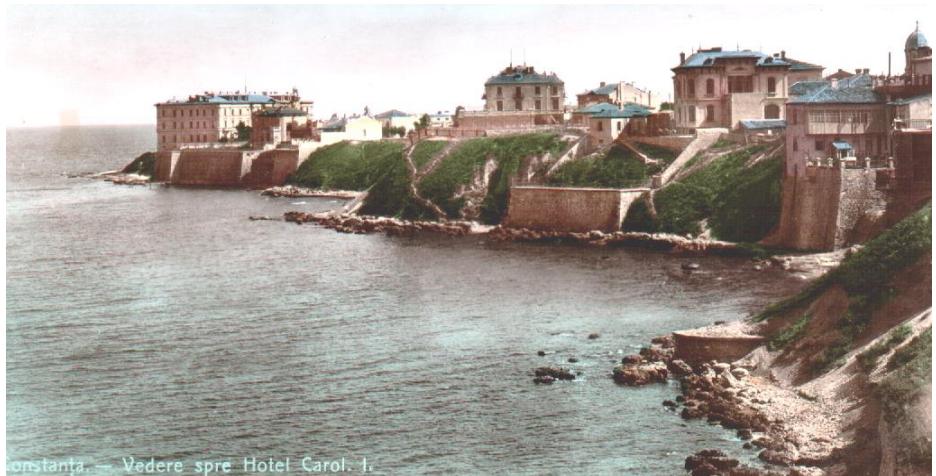
*Figure 4.8 (above)  
– Northern Cliff – collapsed terraces  
(Archives of Constanța City Hall)*

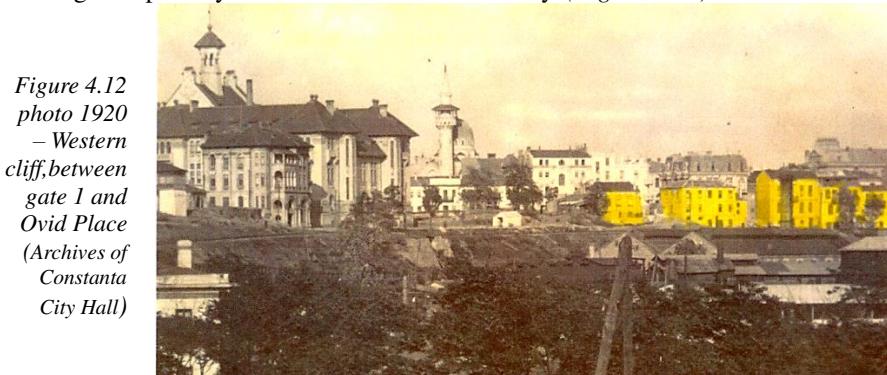
Figure 4.12  
photo 1920  
– Western  
cliff, between  
gate 1 and  
Ovid Place  
(Archives of  
Constanța  
City Hall)

In the Western part of the cliff, near the commercial harbor, the front raw of building collapsed by 1950 – 1960 due to instability. (Figure 4.12)

- In primul plan – dreapta jos (port) – cladirile aferente depoului feroviar (dezafectate)
- In plan secund – dreapta – frontul construit de pe latura de sud a str. Ovidiu, distrus in intregime pana in anii 1950-1960 datorita fenomenelor permanente de surpare a falezelor.

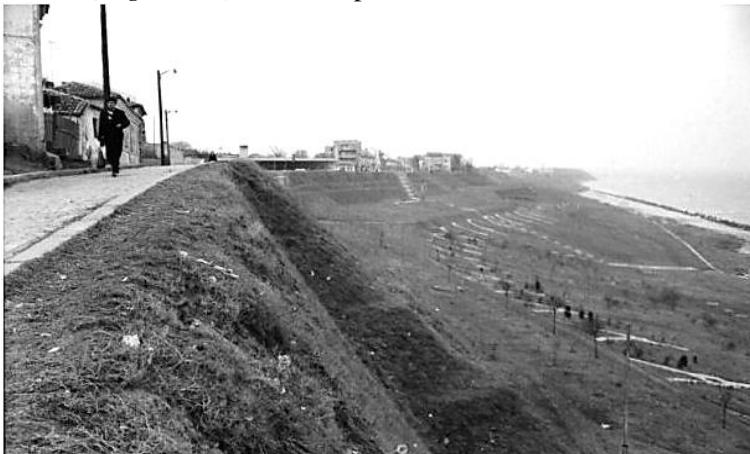
*Figure 5.3- Caramidari Street before collapsing  
(Archives of Constanta City Hall)*

1. cliff collapse along the present Negru Voda Street(*Figure 5.4*);
2. frequent cliff collapses in the North of Aristide Karatzali Street (*Figure 5.5, Figure 5.6*);
3. successive collapses of the built area on the Eastern side of Caramidari street (*Figure 5.3*), last collapse – around 1970;

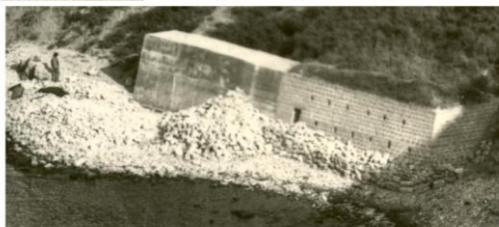
Imagini cu prabuziri ale unor constructii aferente imobilelor situate pe str. A.Karatzali nr.14 si 12, in urma surpari falezei.  
Sunt surprinse lucrari de sprijin a curtii imobilului de la nr. 8 -10

Ziduri masive din piatra si beton realizate la baza falezei pentru oprirea fenomenelor de surpare.

Zidul din dreapta este prevazut si cu drenuri orizontale pentru

*Figure 5.6  
- photo 1915 – 1920 - details of clear cliff instability , affecting the buildings*

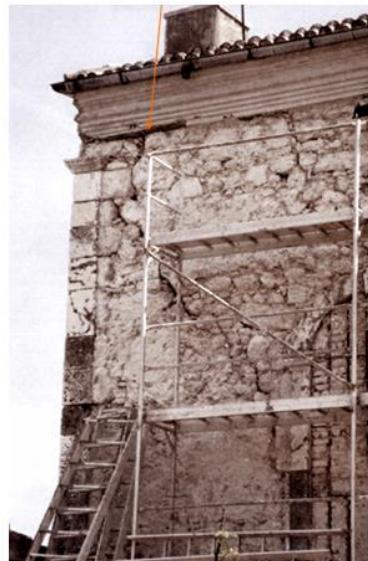
COLTUL DE N – E

Sunt vizibile fisuri relativ mai vechi care marcheaza tendinta de prabusire a coltului de nord - est al cladirii.

In prezent sunt acoperite de tencuiala noua.

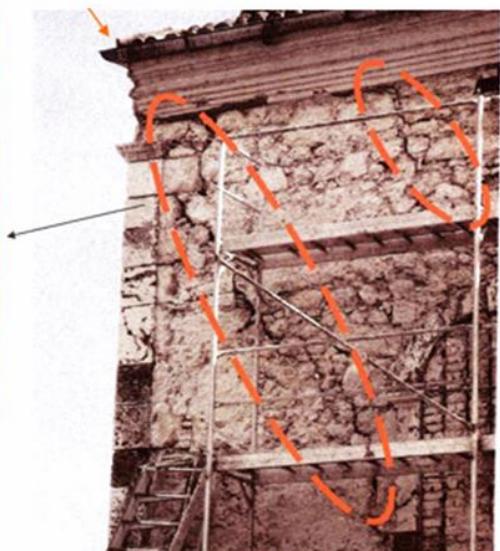
*Figure 5.9 – Front side of the Greek Church - details  
May 2006 -*

The North-Eastern corner of the building has deep vertical fissures marking a clear proof of collapsing

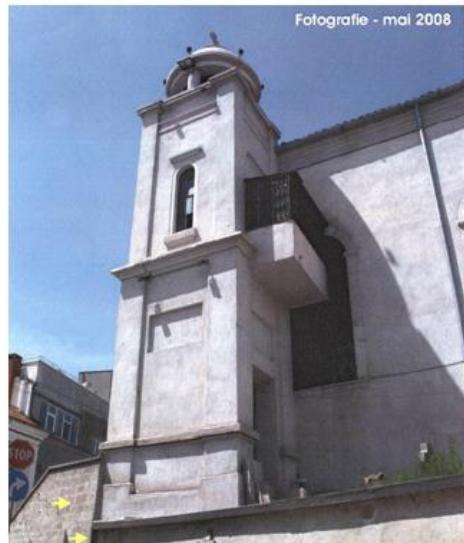
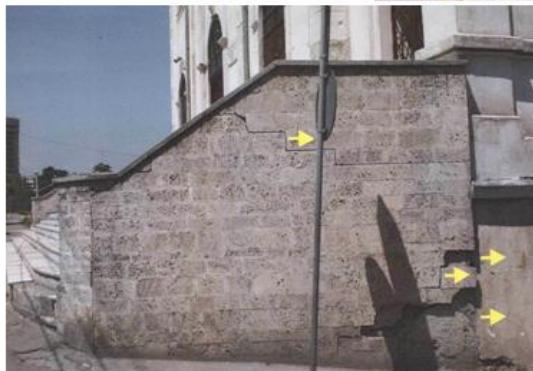
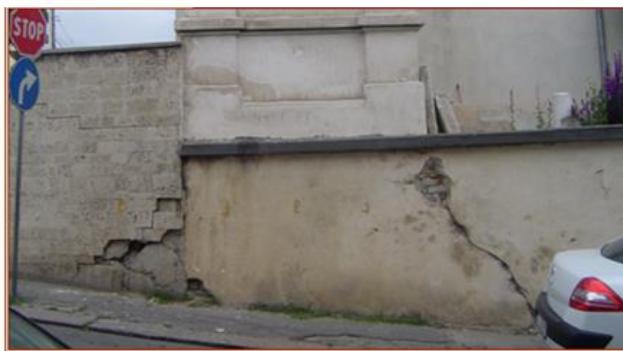
Figure 5.11

The South Eastern corner has rather recent fissures on the wall that supports the bell dome marking the moving tendency towards East of the entire building. (Figure 5.10, 5.11)

clear  
fissures S-V part

Deeper fissures, showing a permanent damaging process of the building

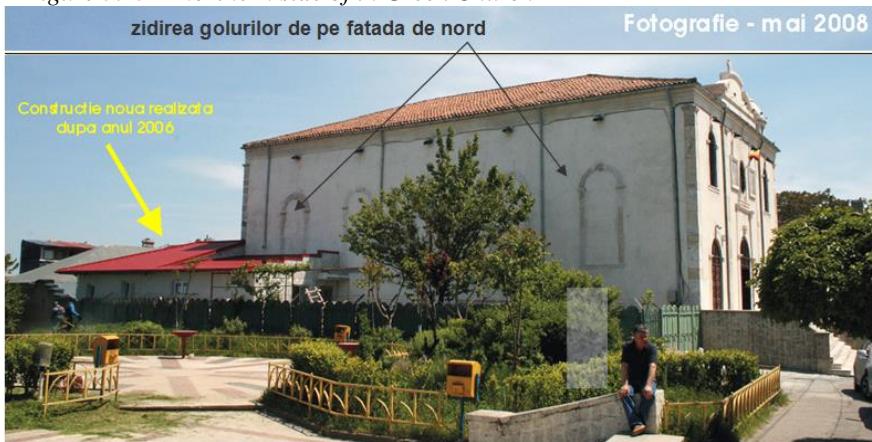
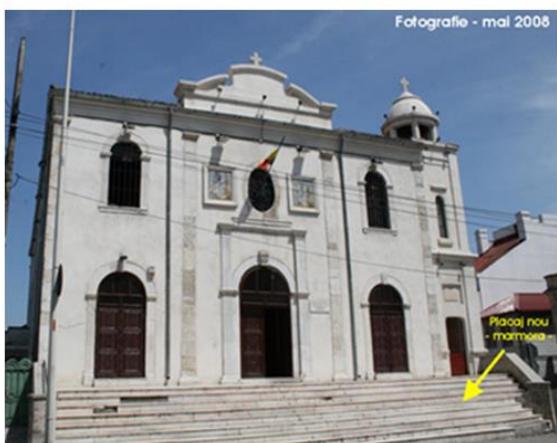
*Figure 5.15 – Northern side of the Greek Church*

*Figura 5.16 - Biserica Greaca fatada principală*

- filling the empty window spaces on the Northern part;
- general repairing in 2005-2006, according to license no 2421/17.09.2004, without complying with its main provisions:
  - Annexed buildings (storages) of the North Eastern corner of the church were replaced and extended with permanent constructions as residences; (*Figure 5.15*)
  - The step platform made of ancient stone as totally covered with Marmora; (*Figure 5.16*)
