“OVIDIUS” UNIVERSITY OF CONSTANTA

**CONTRIBUTIONS REGARDING THE RESTORATION AND
CONSOLIDATION OF MUSLIM WORSHIPS BUILDINGS**

ABSTRACT OF DOCTORAL THESIS

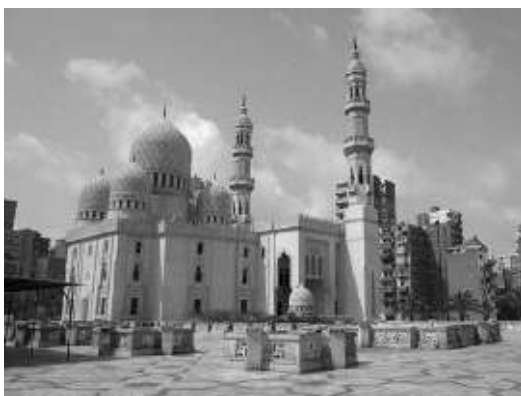
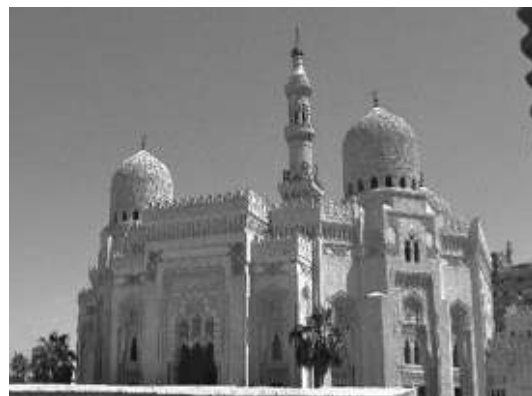
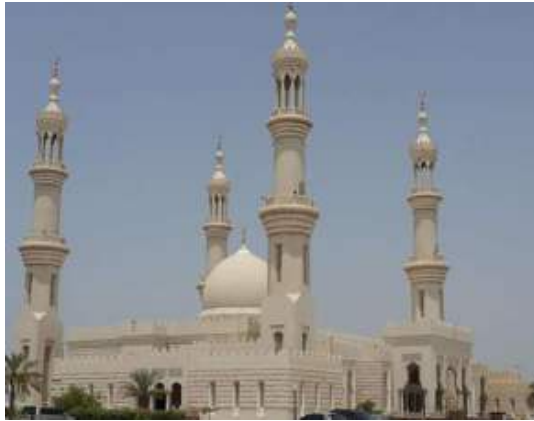
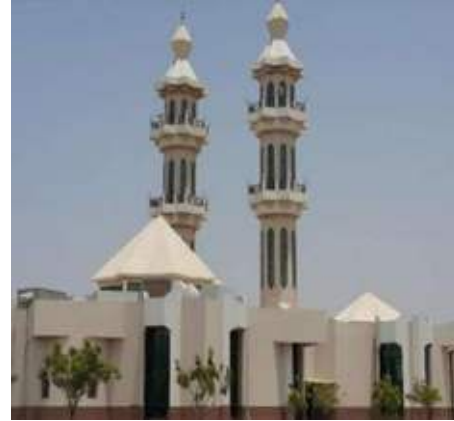
Fig. 1.2. Egypt and Syria minarets:

1. Egypt and Syria area minarets – the size of the minarets is variable depending on their height. This shape ensures an efficient distribution of the material and at the same time a better behavior in seismic action. As a rule, they have several balconies, and at the top of the minarets there is a dome that ends with a peak that represents the connection with the divinity, unlike the minarets in Dobrogea where the peak is in the form of a cone trunk, the cone being made of wood with lead sheets. With reference to the base area of the minaret, it is specified that a common element represents the geometry of this base, which is a square prism.

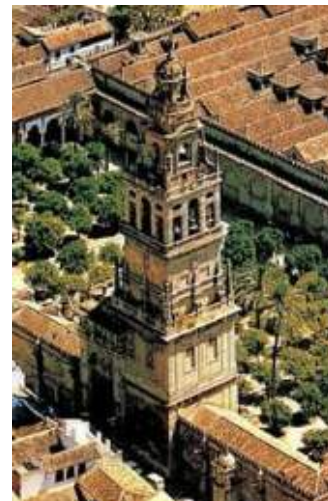
Fig.1.3. Morocco and Spain minarets

a) Al Zitouna mosque, Tunis [63]; b) Cordoba mosque, Spain [164]

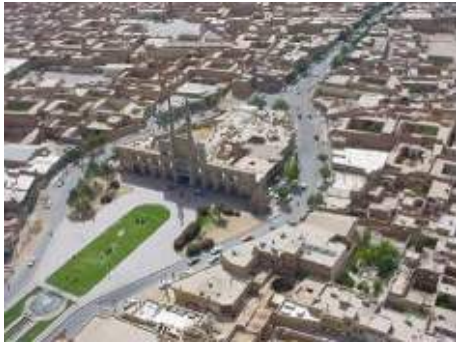
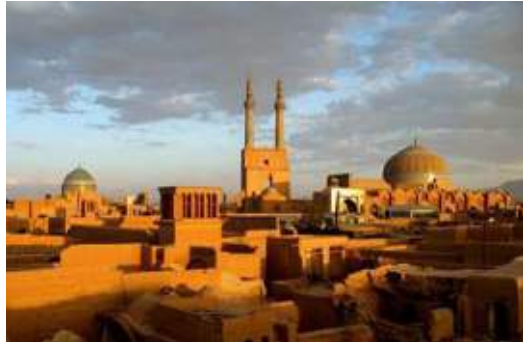
3. Minarets in the Persian areas – they are characterized by a specific geometric shape in the form of tall, slender, conical or round turrets generally arranged in pairs and which outline an entrance way.

Fig.1.4.Minarets in the Persian areas, Yazd city, Iran [84]

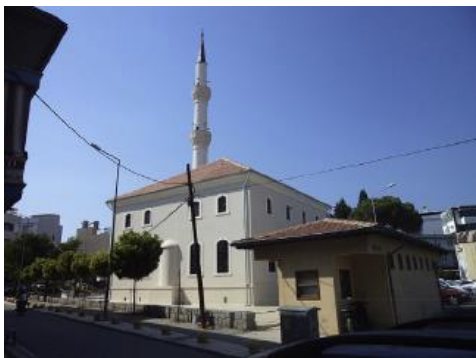
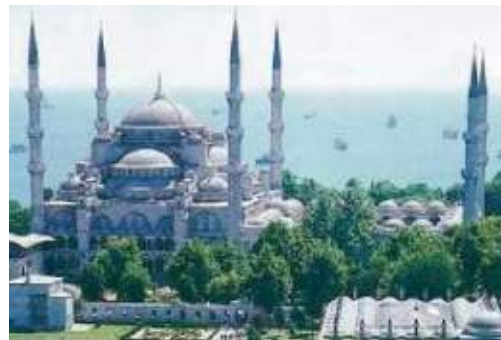
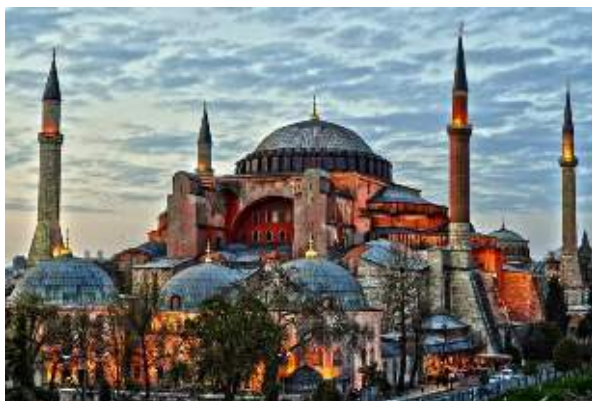
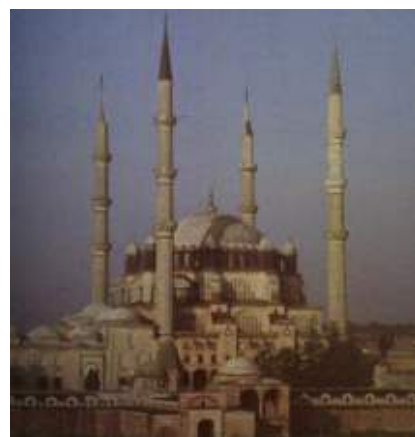
Fig.1.5. Turkish minarets

4. Turkish minarets - they resemble Persian minarets with a slender structure, having a conical, round or polygonal shape. Turkish minarets can even have two or three balconies.

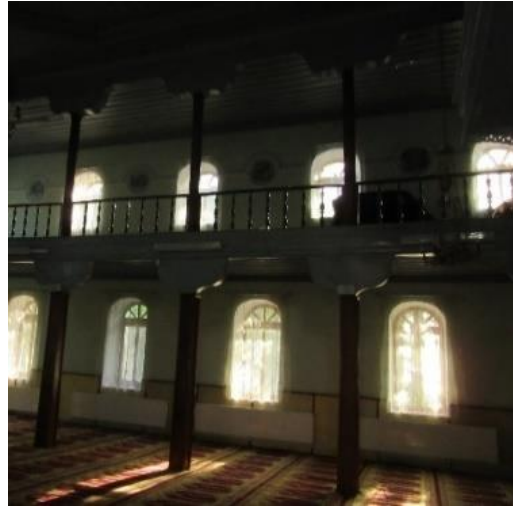
bordered on 3 sides by a gallery formed by beautifully ornamented wooden pillars on which the balcony discharges. The balcony is intended for Muslim women, access is from the antechamber of the mosque. In some mosques, the balcony is structured on one side. This characteristic is found when the aspect ratio L/l is higher (eg. Esmahan Sultan Mosque, Hunchiar Mosque).

Fig.2.1. The balcony – mosque from Medgidia [108]

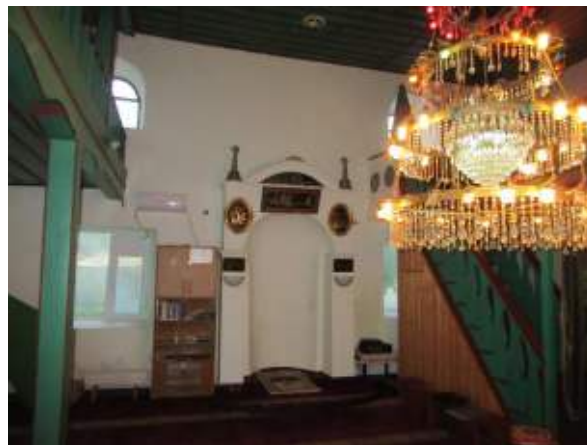
The free side that is in front of the central balcony and in front of the prayers on the ground floor is for the imam. There is the mihrab (similar to the altar), the orientation of this wall is towards Mecca and is called the Qibla wall. This wall is not ornamental, where a niche is found, and quotations from the Koran are found.

Fig. 2.2. The mosque from Cernavoda mihrab [18]

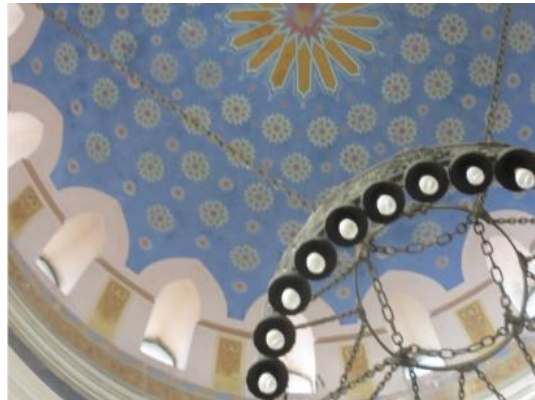
ceiling of the mosque is plastered and painted, with colors and shapes of divine beauty. The dome does not exist at the other mosques in Dobrogea. The roof is made of wood, and the interior ceiling is beautifully decorated with planks. Ceilings in Islamic architecture represent heaven, and the presence of figures drawn on ceilings and walls is prohibited in Islamic architecture, as believers must have the power to imagine divine power. The prayers on their way to the prayer hall intersect with the door that represents the first element of the mosque, most of which are made of beautifully carved wood.

Fig. 2.4. Plastered and painted ceiling – Carol I mosque (author's photo)

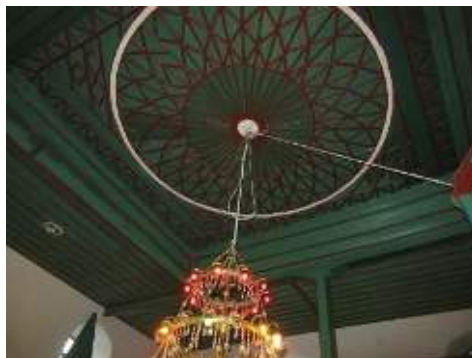
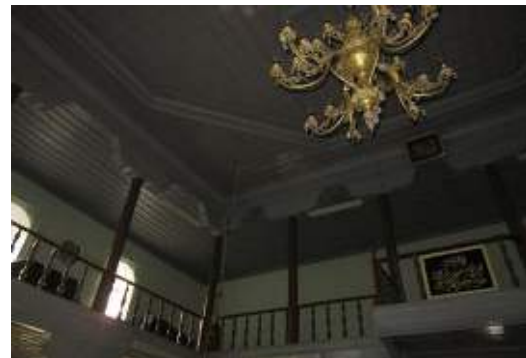
Fig.2.5. Wooden ceilings – left: mosque from Cernavoda; - right: mosque from Medgidia[18]

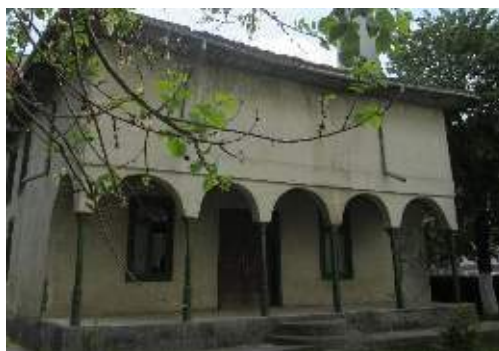
In some situations, the mosque construction is provided with a veranda, which can be made of wood or stone masonry and which can be found at the Esmahan Sultan Mosque in Mangalia in the wooden version. At the one in Harsova, from the research carried out, it appears that the veranda was abolished, observing the initial situation following an expertise of the facade. The analysis of the research project highlighted the fact that the mosque from Harsova had an open veranda similar to the one from the mosque from Isaccea and Babadag, which was later closed. At the Harsova mosque, access from the minaret is from the vestibule, similar to the situation in Medgidia. Unlike the other mosques in Dobrogea where the entrance from the minaret is from the upper gallery. Another veranda made in a mixed version can be found at the mosque from Isaccea, where the elements on which the roof rests are made of beautifully ornamented wood.

Fig.2.7. The mosque from Isaccea veranda

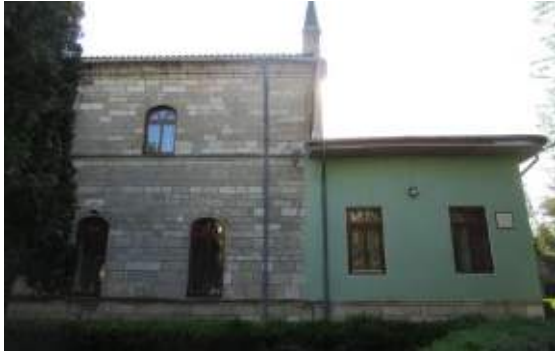
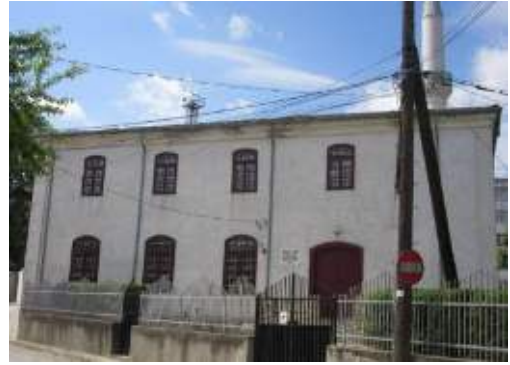
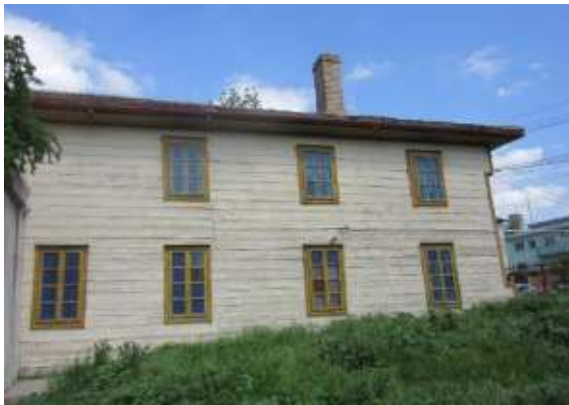
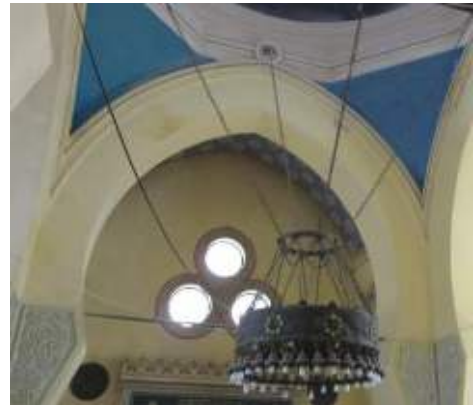
The lighting of the prayer rooms is achieved both naturally through the presence of a large number of windows arranged on one or two levels, and artificially. In the case of the Carol I mosque in Constanța, there are also windows at the level of the dome, thus creating a very good light. The sizes of the windows vary according to the constructive characteristics of the mosque: they are found both in circular form (Carol I mosque), rectangular or finished with arches at the top (Hunchiar mosque), rectangular (the mosque in Harsova and Cernavoda). Windows are usually arranged on the walls perpendicular to the wall where the niche is located, and on the wall in front of it. Unfortunately, the window frames have not been preserved from the construction until now, the vast majority of them having PVC frames but also wood or iron. The artificial method of lighting is achieved by using electric current. In the middle of the prayer halls there are large chandeliers and they have shapes that fit perfectly into the architecture of the prayer halls.

Fig. 2.8. Window types (author's photo) : a) mosque in Medgidia, b) mosque in Tulcea, c) mosque in Macin, d) Carol I mosque

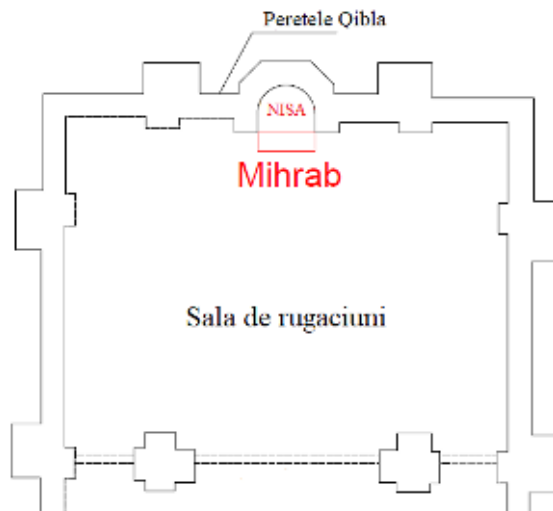
The mihrab represents the place from where the imam holds his services and is distinguished by the presence of the niche, which is signaled by arches and domes and has the role of improving the acoustics of the service. The niche always faces the Muslim holy city of Mecca. The wall on which the mihrab and the niche are located is called the Qiblah wall, being the opposite of the wall where access to the prayer room is made. The decoration of the niches varies, with each mosque having a different niche. The mihrab is positioned in the middle of the Qiblah wall.

Fig. 2.9.1. Mihrab positioning

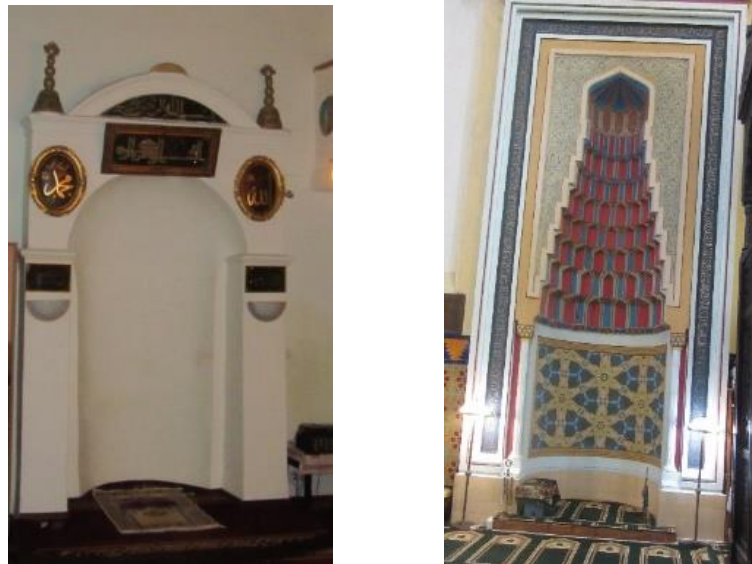
Fig. 2.9.2. Mihrab and niche – left: mosque in Cernavodă, right: Carol I mosque [108]

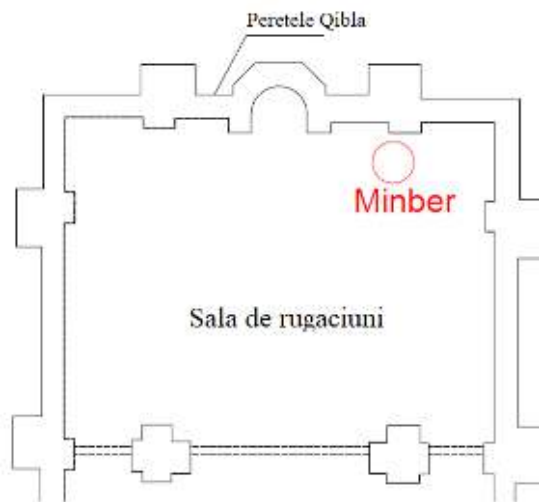
Minber (the big pulpit) comes from the Arabic "nebr" which means raising. It is an important architectural element of mosques, being the place from where the imam is better seen and better heard when he delivers sermons on Fridays and holidays. In the prayer hall it is located on the right side of the mihrab, being one of the most decorated or sculpted elements. The dimensions of the minber vary depending on the dimensions of the mosque and is shaped like a pointed and stepped tower.

Fig. 2.11. Minber positioning

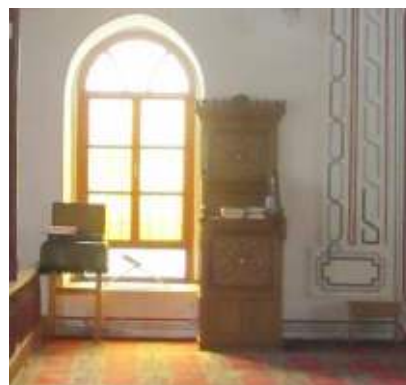
The Kursi (Small Pulpit) is where the imam delivers his sermons. It is located on the left side of the mihrab.

Fig. 2.12. Kursi – mosque in Babadag [108]

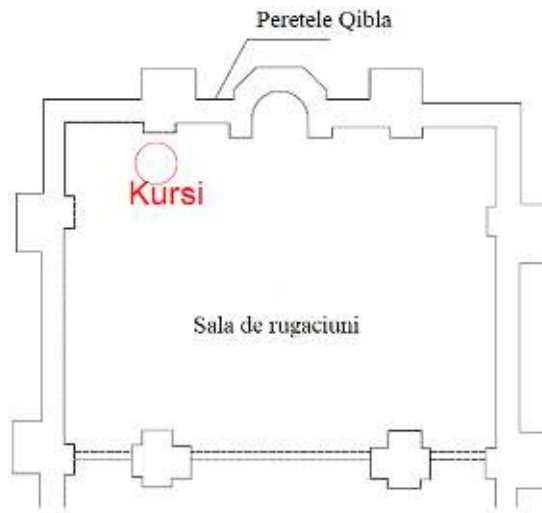
Fig.2.13. Kursi positioning

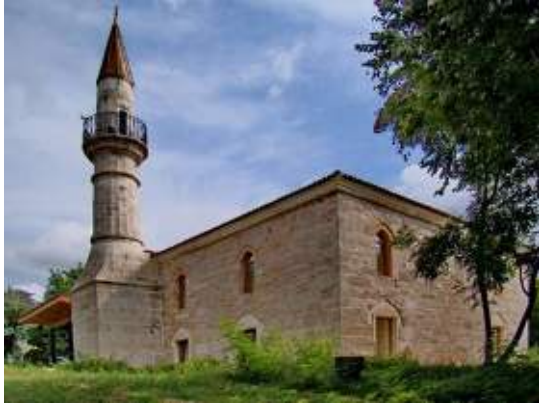
This building is one of the most important Muslim worship places in Dobrogea, built in 1573 by the daughter of one of the greatest sultans of the Ottoman Empire, Selim II, in memory of his father. It is located in Mangalia, in a protected historical value area. It is located about 200m from the Black Sea shores. The frost depth is 80 cm, and the foundations of the mosque and the minaret are located about 1,5 m from the ground level.

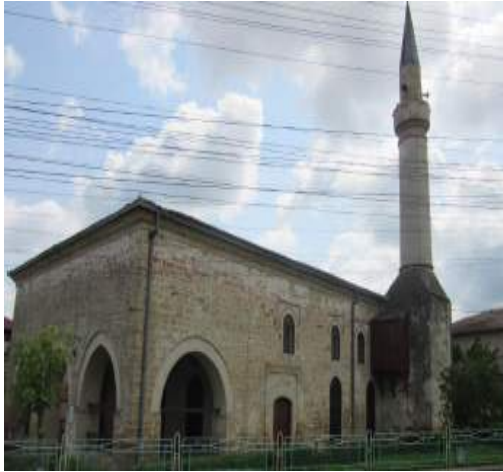
The mosque was built in 1610 and is located in the center of Babadag, on the road between Constanța and Tulcea and more precisely on Geamiei street, number 2. In the courtyard of the mosque there is also the parish house, as well as the graves of General Gazi Ali Pasha and to Sari Saltik Dede. The Babadag Mosque impresses architecturally both inside and out. The mosque went through a fire during the Russo-Turkish War in 1771. After the fire, the roof and ceiling were replaced, additional doors were opened on the sides of the building, and a new minaret was built. The last restoration caused by the destruction is recorded in 1828 when the minaret was rebuilt, the ceiling and the roof were modified, two vestibules were added which were removed after approx. 160 years. The mosque had a museum function until 1989, and in 1990 the restoration works will begin.

- Dimensions: 21,13m x 14,95m (including the veranda)
- Height height: $H_{\text{reaves}} = 7,20\text{m}$, $H_{\text{roof}} = 9\text{m}$, $H_{\text{minaret}} = 23\text{m}$;
- Built area: 334sqm (including veranda and minaret)
- The surface of the prayer hall: 250sqm.
- The foundations of the mosque are made of stone masonry and are continuous under the walls of the mosque.

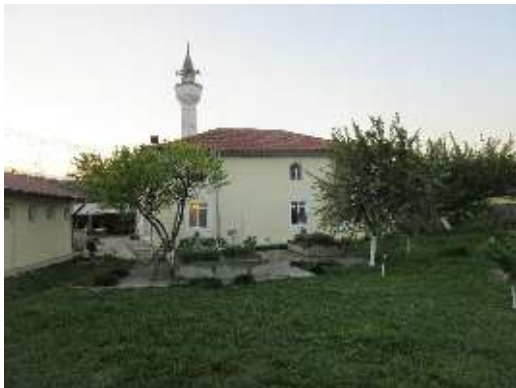
This mosque was built in 1756 during the reign of Sultan Osman III. It is a structure made of stone, and according to the documents the stone that was used to build the mosque, was used before to an old bridge over Carasu Lake. The mosque is located on Anghel Saligny Street, being very close to the Danube-Black Sea canal.

- site characteristics: corner period $T_c = 0,7s$ and terrain acceleration $a_g = 0,2g$;
- Dimensions: $15,79m \times 10,69m$;
- Height regime: $H_{reaves} = 5,7m$, $H_{roof} = 7,7m$, $H_{minaret} = 17m$;
- Built area: $290sqm$;
- The surface of the prayer hall: $163,32sqm$;
- The foundations are continuous under the mosque walls, and are made of stone.

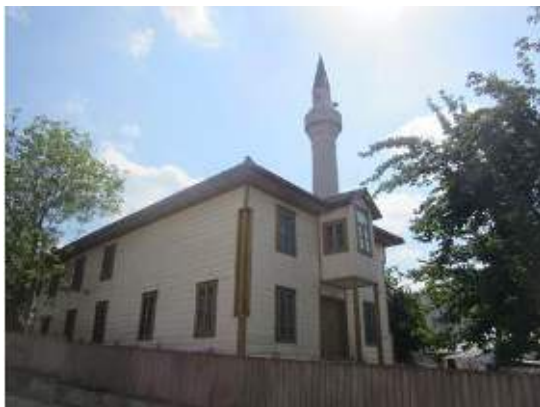
The Mestan Aga Mosque from Macin was built in 1860 by Hagi Berbe Ahmet, about 20 years after the appearance of the Macin community in Tulcea County.

The mosque foundations are made of limestone masonry and are continuous, made under the mosque walls. The frost depth for this site is 80cm.

- Height regime: $H_{\text{reaves}} = 5,10\text{m}$, $H_{\text{coama}} = 7\text{m}$, $H_{\text{minaret}} = 21\text{m}$;
- Built area: 250sqm
- The surface of the prayer hall: 211,26 sqm.

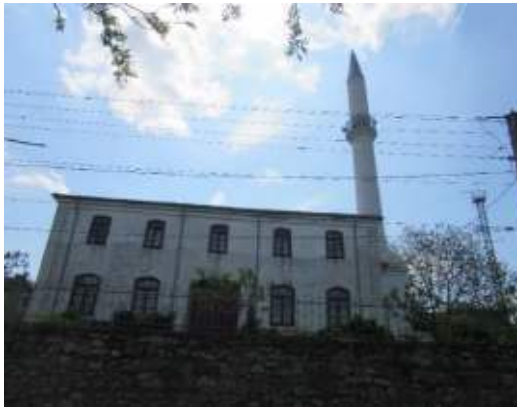
The mosque was built in 1865, having its location on Independentei street, number 2 and called the cathedral due to its historical and cultural importance. It is one of the largest mosques in Dobrogea built by the Ottoman Empire and comparable to the mosque from Medgidia. The rectangular structure in the plan was built by Ahmed Rezim Pasha, during the reign of Sultan Abdul Aziz.

Like any old construction, it has been included in numerous destructive actions of the environment that have led to the degradation of the mosque. For example, 75 years ago the roof was torn off by the wind and replaced with a more moderately sloping roof with awnings.

The mosque passed a restoration process in 1971, carrying out roof repair work, carpentry, interior and exterior work.

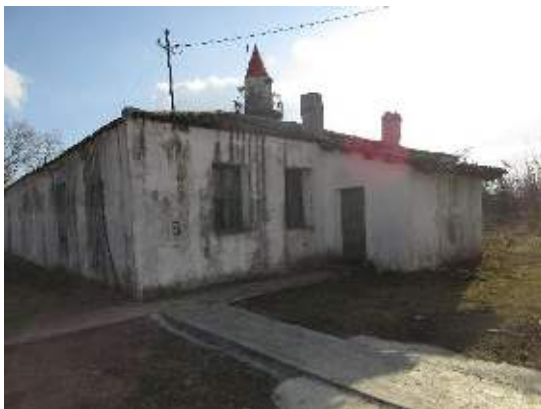
Giuma Mosque is located in the village of Amzacea, the year of construction being recorded at 1850. The construction has a structure made of limestone masonry. Throughout its existence, the mosque has been the target of bombings during the Russo-Turkish wars. Thus, until 1917, the mosque kept its shape, when after a bombardment the minaret collapsed. The minaret was rebuilt only after 10 years, in 1927, but with a much lower height.

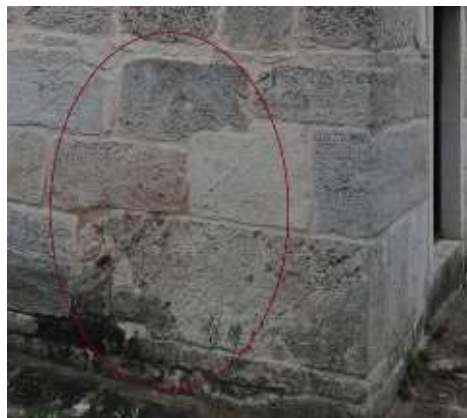
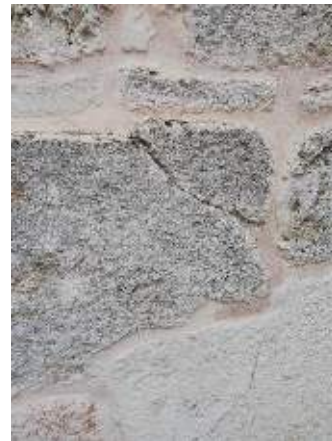
Fig.3.3. The cracking and disintegration of masonry stones – Esmahan Sultan mosque
(author's photo)

More than 10 years after the last restoration, cracks in the masonry stones reappeared on the walls, due to uneven settlement. Another phenomenon that occurs on masonry stone is disintegration. It is a phenomenon that can affect both the surface of the stone and its depth, and the destruction generally starts from the surface of the material.

Other degradations in the masonry walls, which were observed at the Esmahan Sultan mosque in Mangalia, are:

- Cracks appearing in the masonry mortar, both in the area of the windows and on the rest of the surface;
- Mortar separation in several places;
- Chromatic alteration at the base of the walls, and biological colonization caused by high humidity;

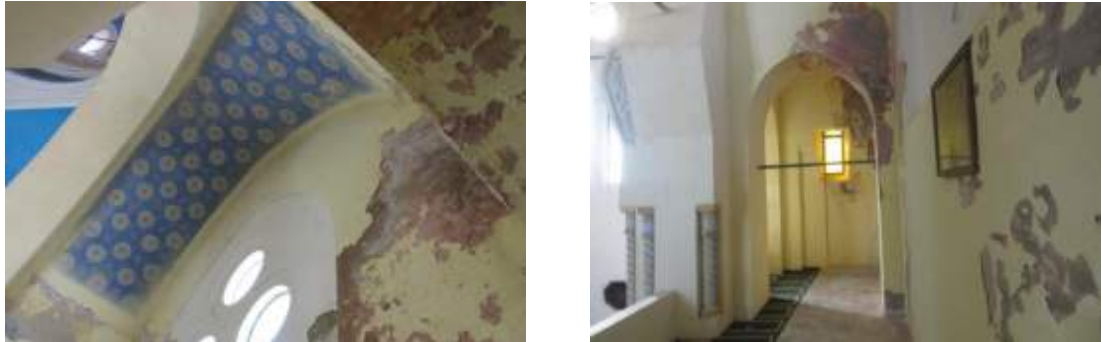
Fig.3.4. Carol I Mosque – degraded areas of interior walls (author’s photo)

At the Carol I mosque, many areas with exfoliated paint were found both on the walls and in the dome area. Due to water infiltration in the area of the dome windows, the decorative elements of the painting have been erased. And in the case of the mosques from Cernavoda, Mangalia and Tulcea, the high humidity is the cause of degradation of the interior finishes at the base of the walls and around the windows.

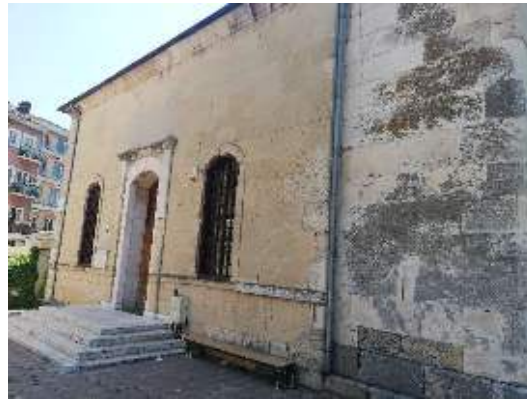
Fig. 5.1. Hunchiar mosque (author's photo)

Following the investigations according to the investigation stages presented in the study, the results necessary for the structural and functional mosque analysis were thus obtained.

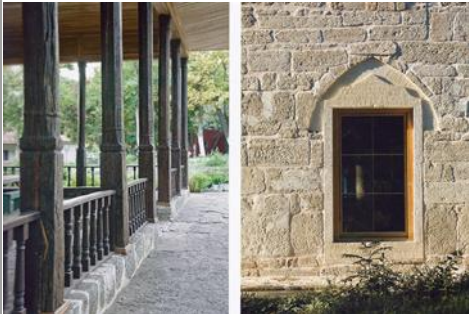
Veranda – unique for this mosque. The veranda is made of oak wood.
6.6.	Structure	Masonry structure
6.7.	Building material	Carved limestone
6.8.	Roof building material	Wooden frame, wool covering
6.9.	Building techniques	Limestone masonry carved by Turkish master masons with manual technology, the masonry is bound with metal screeds, but lime-sand mortar is also found. It is the only

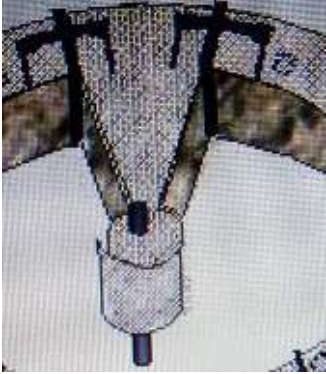
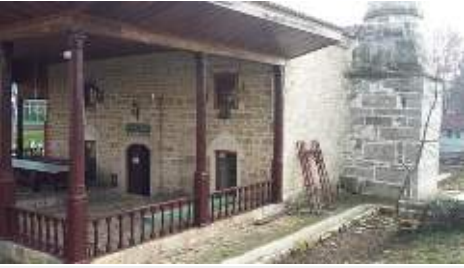
<p>mosque that uses cast-in-place steel frames, both in the minaret and in the construction itself for tying the stones. It is the only mosque in Dobrogea where this technology is found. The mihrab is made in Moorish style.</p>

<p>Mihrab architecture in the Moorish style; Bonding stone blocks with metal; The niche in the ceiling that provides acoustics; The veranda before the entrance; The use of prefabricated elements in the construction of the staircase from the minaret;</p>
<p>6.11.</p>	<p>Dimensions</p>
